**#17-NA-259: Body Creak Noise from Rear Seat Area -  
(Aug 16, 2017)**

Subject: Body Creak Noise from Rear Seat Area

| Brand: | Model: | Model Year: | | VIN: | | Engine: | Transmission: |
|---|---|---|---|---|---|---|---|
| Chevrolet | Camaro | 2016 | 2018 | | | All | All |

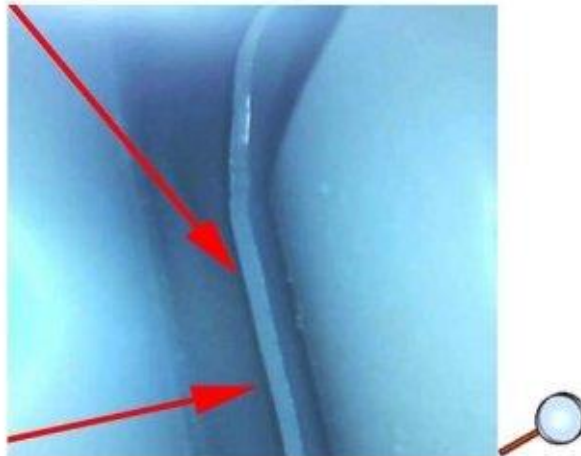
4. With the borescope inspect the two panels for either missing bond or imperfections.
- If imperfections are not visible, continue to Step 12.
